# Inspection Report

## Sample Report

**Property Address:**  
2291 Boot lake road  
Eagle River WI 54521

**Homestead Inspections, LLC**

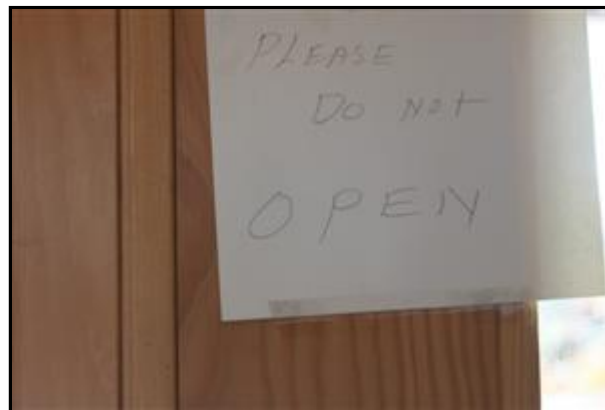
2.1 Picture 1

Repair or Replace

Lower patio doors are not working properly repairs are needed.

Lower patio doors are not working properly repairs are needed.

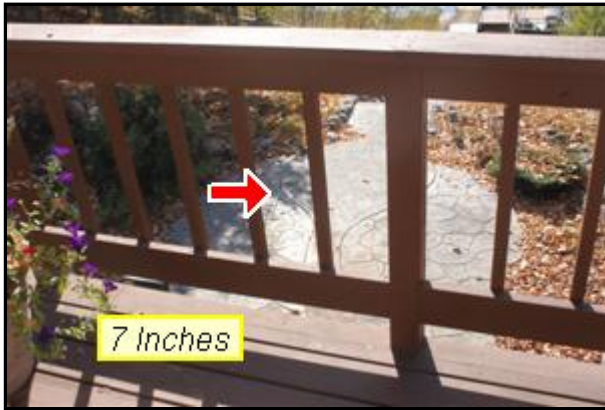
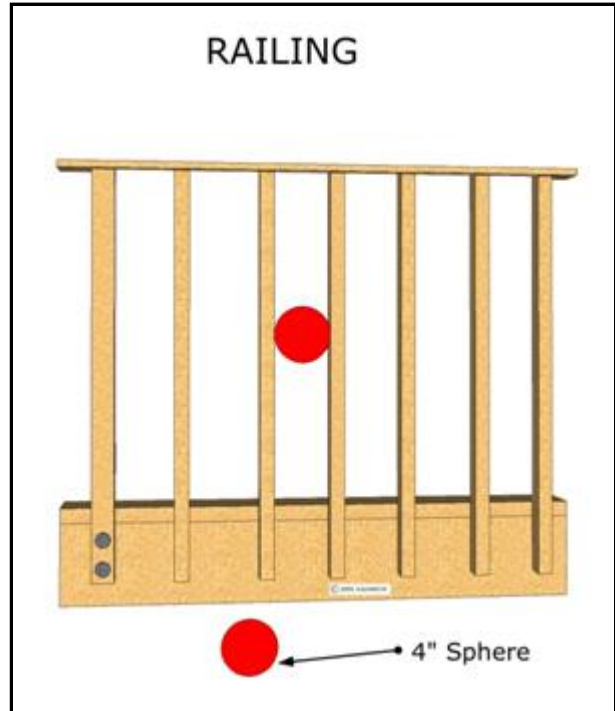
2.6 Picture 1

Safety concern

- ❌ (1) Spindles are too far apart. Additional spindles should be added to rails to lesson the spaces between them. This can be hazardous to small children. They should be no more than 4 inches apart.

(1) Spindles are too far apart. Additional spindles should be added to rails to lesson the spaces between them. This can be hazardous to small children. They should be no more than 4 inches apart.

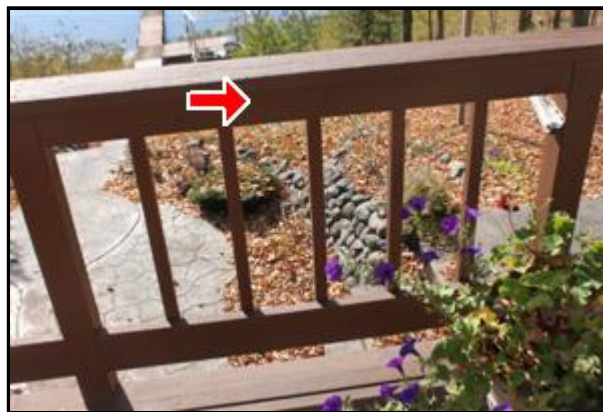
2.6 Picture 3

- (2) The inspector noted loose rails. This can be a very dangerous condition and should be repaired as soon as possible.

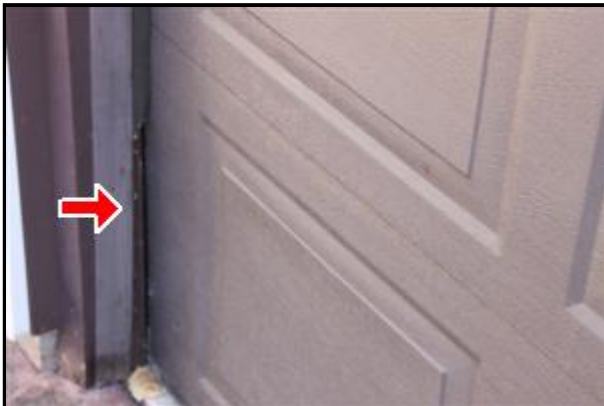
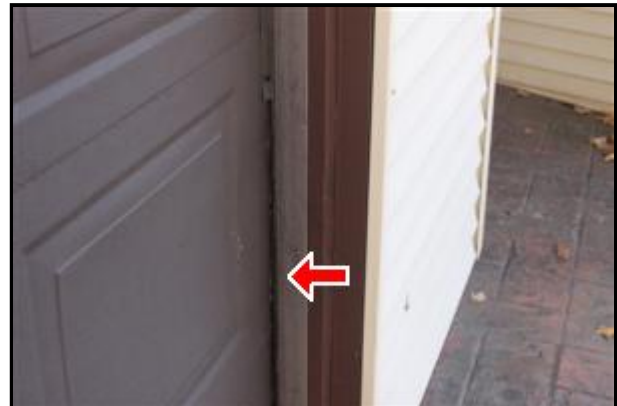
3.2 Picture 1

Maintenance Required

- ⚠ The weather stripping on the garage door(s) is either worn or missing. Weather stripping not only helps to prevent entry of debris, etc. into the building, but also protects the door itself. Without weather stripping present the door may begin to wick moisture up into the door; over time, this may cause decay and deterioration of the door. Repair or replace as necessary.

The weather stripping on the garage door(s) is either worn or missing. Weather stripping not only helps to prevent entry of debris, etc. into the building, but also protects the door itself. Without weather stripping present the door may begin to wick moisture up into the door; over time, this may cause decay and deterioration of the door. Repair or replace as necessary.

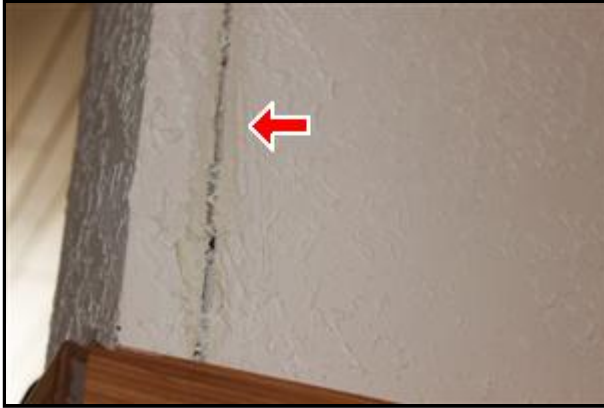
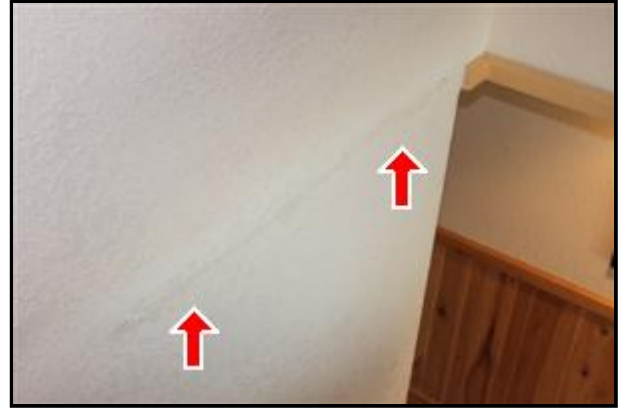
4.2 Picture 1

Manintenance Required

- Some cracks were noted that are minor in nature. Small settlement cracks are a common occurrence and can be repaired, providing the settlement has stopped.

Some cracks were noted that are minor in nature. Small settlement cracks are a common occurrence and can be repaired, providing the settlement has stopped.

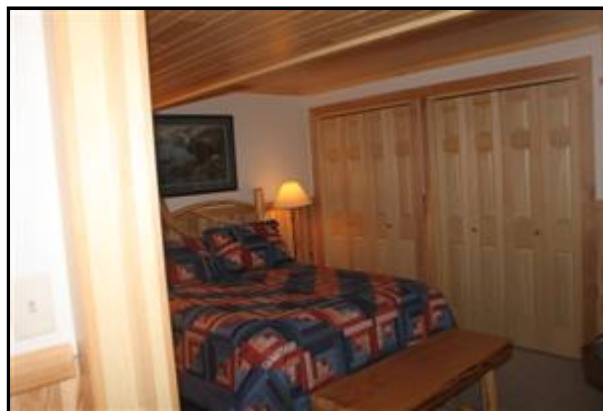
4.6 Picture 1

The room on the lower level currently being used as a bedroom does not have proper egress. There are many variables that affect the placement, size, height, etc. of egress windows. If you intend to continue using this room as sleeping quarters contact a qualified builder for instructions on proper installation of egress window(s).

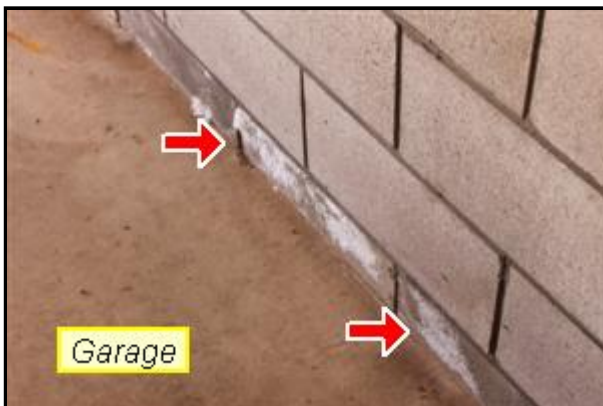
5.1 Picture 1

**Maintenance Required**

- White efflorescence (powder substance) on block wall indicates moisture is in contact with the masonry. This does not necessarily indicate that intrusion will occur. I recommend checking the gutters and the downspout drain lines for proper operation. Also, a water proofing paint could be applied to the interior side of the block if necessary. Efflorescence is found on many homes without water intrusion occurring inside the home. But, it should alert you to the possibility that future steps may be needed.

White efflorescence (powder substance) on block wall indicates moisture is in contact with the masonry. This does not necessarily indicate that intrusion will occur. I recommend checking the gutters and the downspout drain lines for proper operation. Also, a water proofing paint could be applied to the interior side of the block if necessary. Efflorescence is found on many homes without water intrusion occurring inside the home. But, it should alert you to the possibility that future steps may be needed.

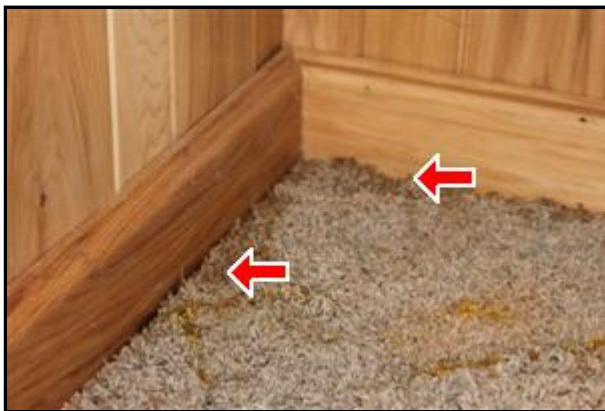
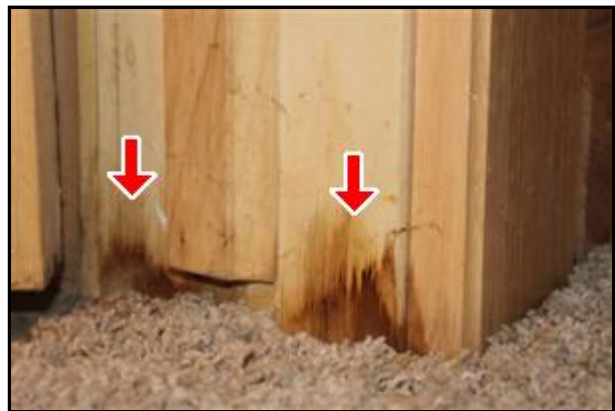
5.9 Picture 1

Repair or Replace

🔧 Visible signs of water intrusion in the basement are present from water. Water intrusion can cause deterioration and excessive moisture on building components if not corrected.. I recommend further investigation or correction by a qualified licensed contractor or water infiltration specialist.

Visible signs of water intrusion in the basement are present from water. Water intrusion can cause deterioration and excessive moisture on building components if not corrected.. I recommend further investigation or correction by a qualified licensed contractor or water infiltration specialist.

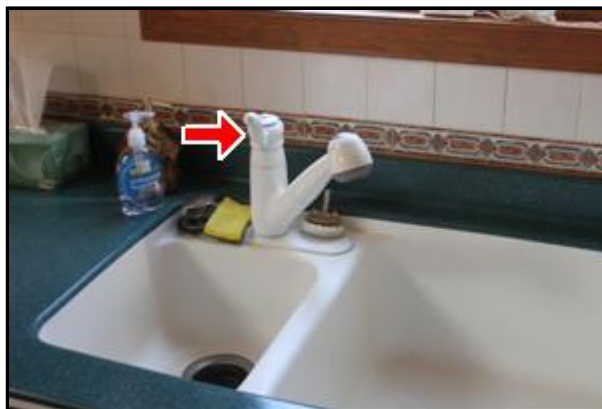
6.3 Picture 1

Safety concern

- ⊕ The hot and the cold are reversed (Kitchen faucet)

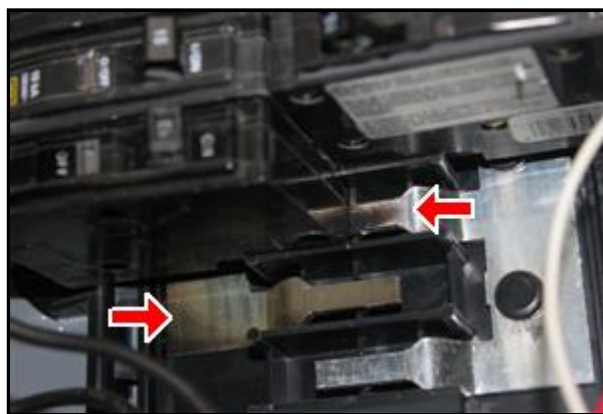
7.1 Picture 1

Safety concern

**+** The bus bar in the main panel is showing signs of over heating. Recommend that you have a licensed electrical contractor evaluate the panel and make repairs.

The bus bar in the main panel is showing signs of over heating. Recommend that you have a licensed electrical contractor evaluate the panel and make repairs.

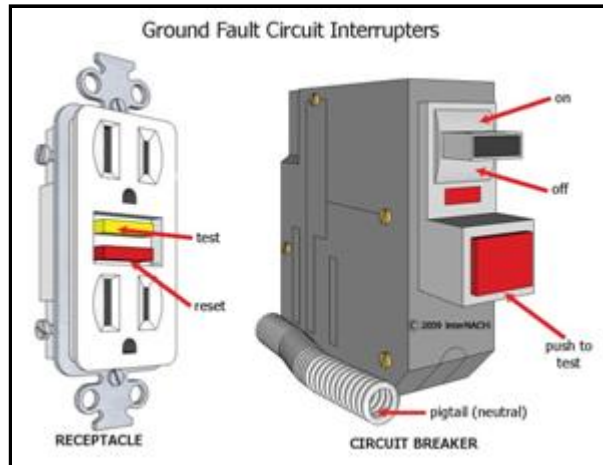
7.4 Picture 1

Safety concern

- +** There is no GFCI (Ground Fault Circuit Interrupter) protection noted on some of the interior outlets. GFCI are recommended in kitchens counter top outlets, bathrooms, spas, garages, unfinished basements and crawl spaces. First floor bathroom and the second floor bathroom.

There is no GFCI (Ground Fault Circuit Interrupter) protection noted on some of the interior outlets. GFCI are recommended in kitchens counter top outlets, bathrooms, spas, garages, unfinished basements and crawl spaces. First floor bathroom and the second floor bathroom.

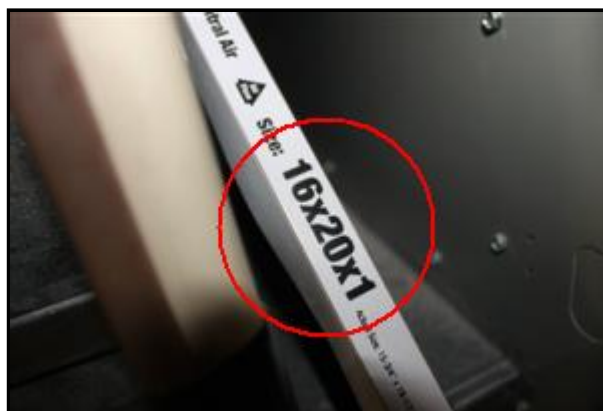
8.5 Picture 1

FYI

Filter size
